Project Title: Evaluation of Low Cycle Fatigue Samples of Alloy 718

Sponsor: General Electric, Gas Turbine Division

FINAL REPORT

EVALUATION OF LOW CYCLE FATIGUE  
SAMPLES OF ALLOY 718

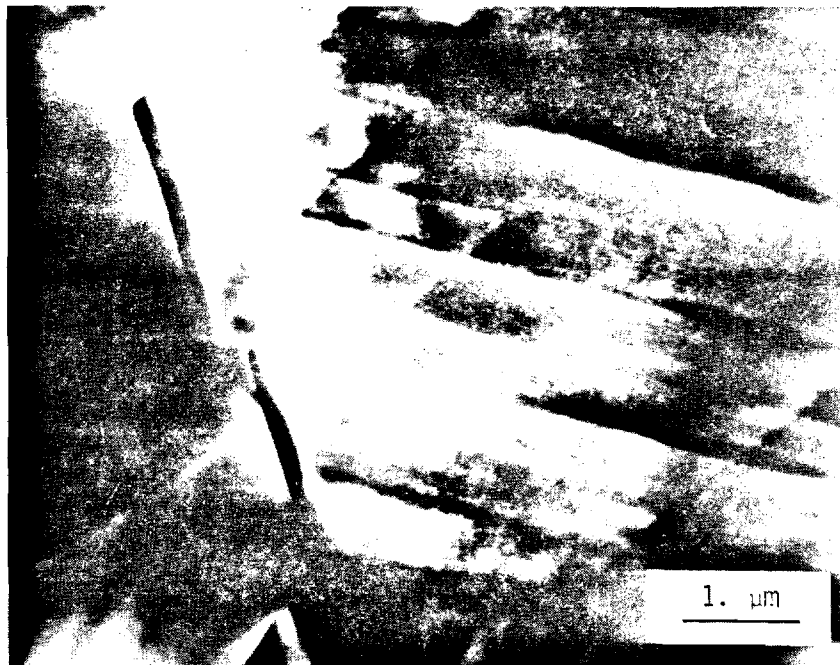
Figure 3. Electron micrographs showing the planar deformation features present in specimen 31.

The characterization of the planar deformation was based on two relevant observations. When the volume fraction of the planar defects was high, as in the case shown in Figures 3 and 4, diffuse intensity along matrix  $\langle 111 \rangle$  directions was observed in the SAD patterns, Figures 5 and 6. The thickness of these planar defects,  $t$ , is significantly smaller than the length and width; consequently, the two dimensional characteristic of these defects caused strong two dimensional diffraction effects. Since the plane of the defects was parallel to  $\{111\}$  of the matrix, the streaks would be perpendicular to these planes, and thus lie along  $\langle 111 \rangle$  directions, Figure 7.

Decreasing the strain-range appeared to increase the average spacing between the twin bands. For example, this can be seen by comparing Figures 3 and 4 with Figures 8 and 9.

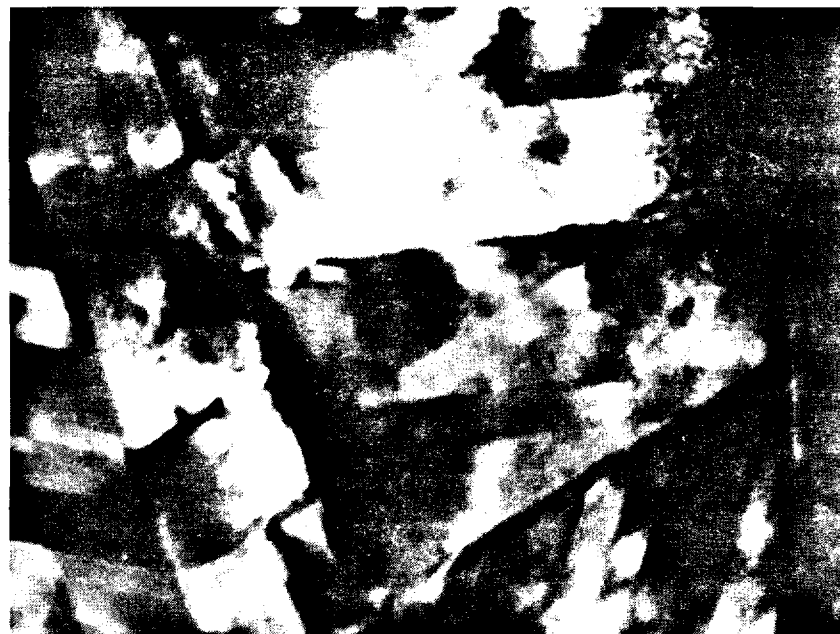
Figure 4. TEM's showing the planar deformation features in specimen 31.

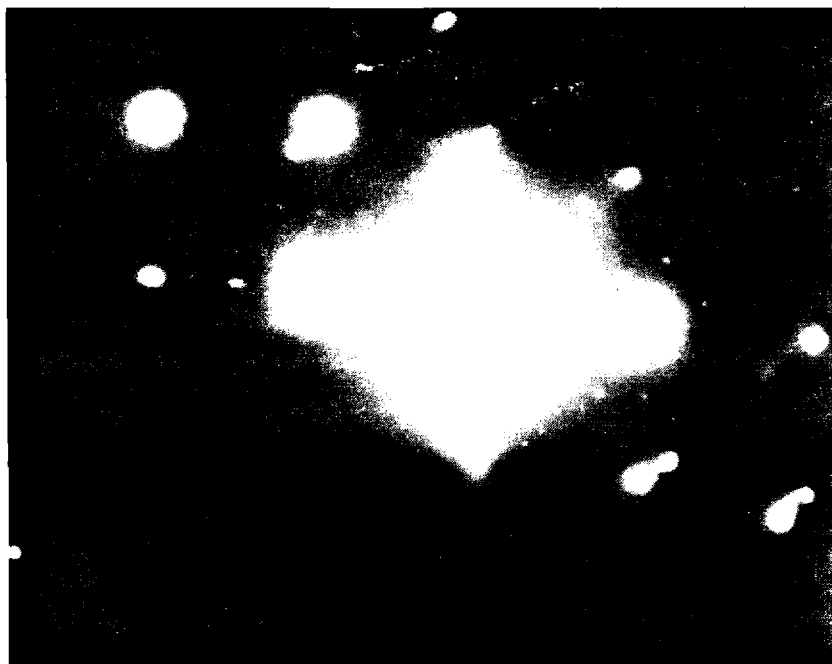
Figure 5. SAD and DF image showing that the extra reflections are associated with the planar defects (specimen 31).

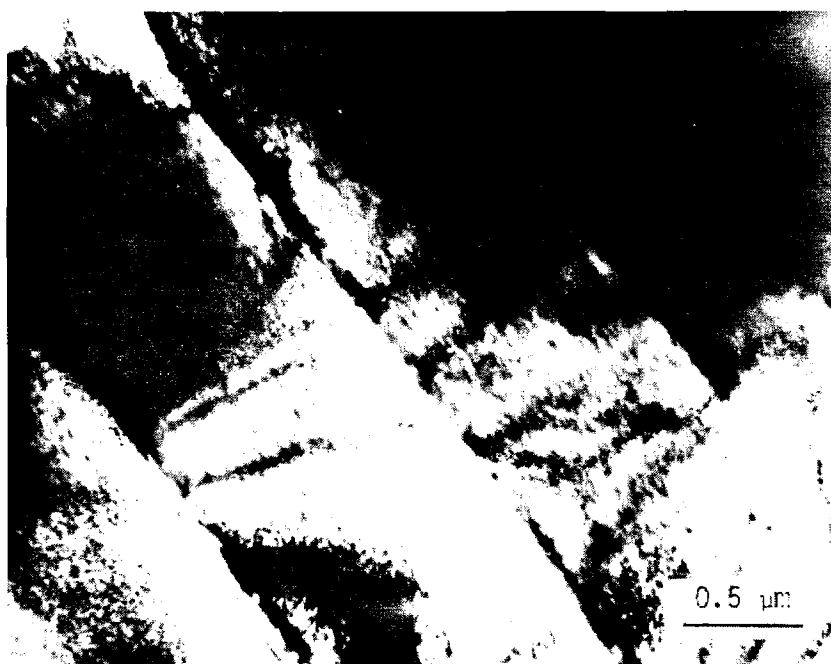
Figure 6. B.F. of area in Figure 5.

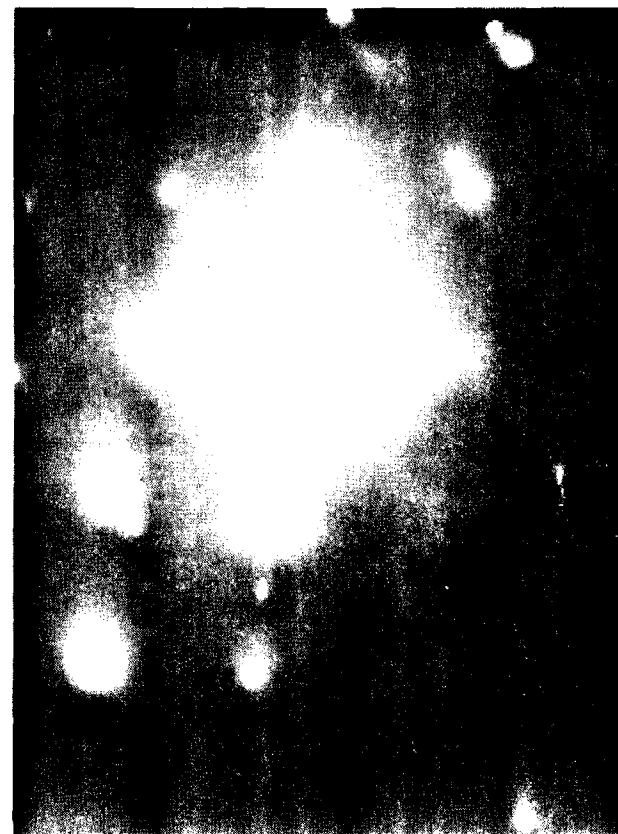
Figure 7. Stereographic projection and SAD illustrating the relationship between the diffuse streaks and the matrix  $\langle 111 \rangle$  directions (specimen 31).

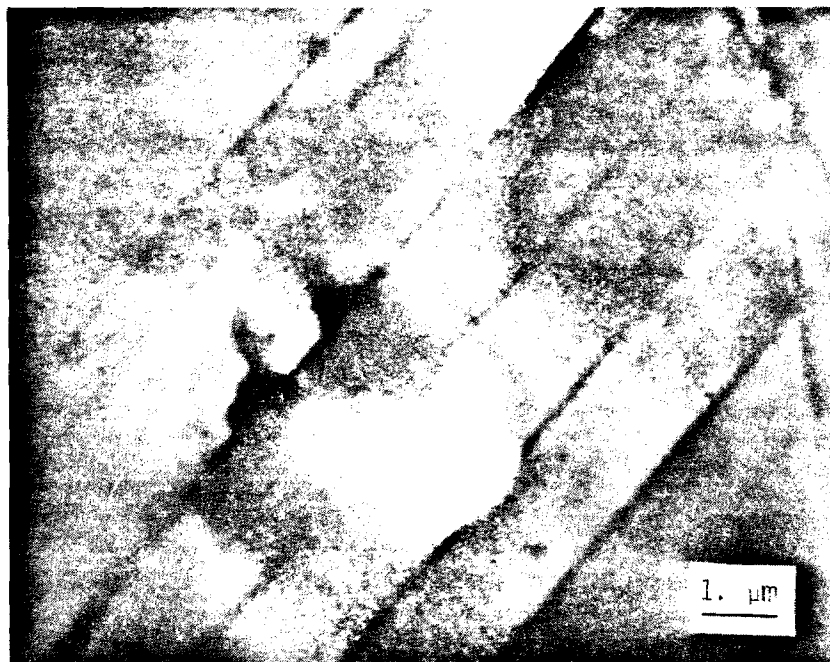
Figure 8. Deformation structure in specimen 34.

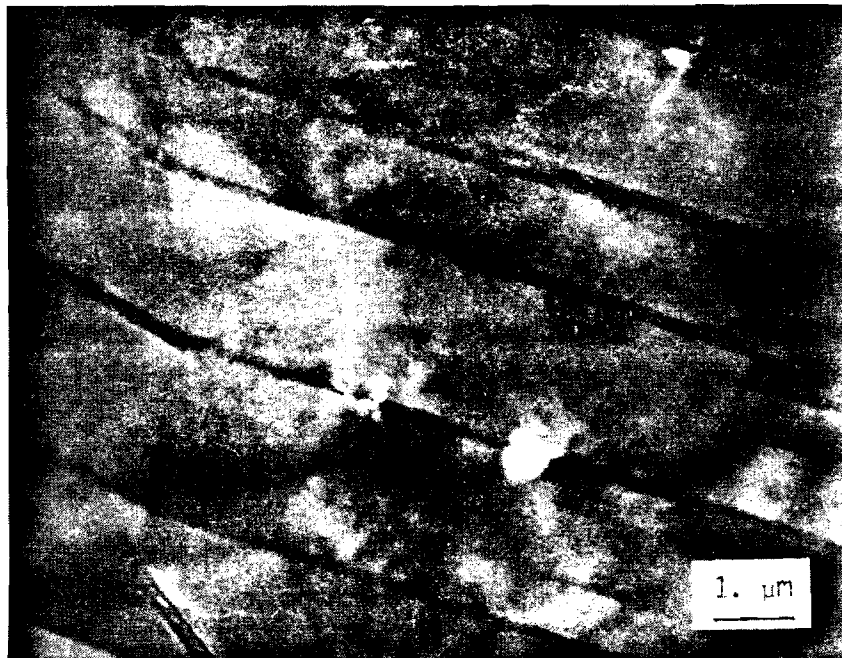
Figure 9. Deformation structure in specimen 34.

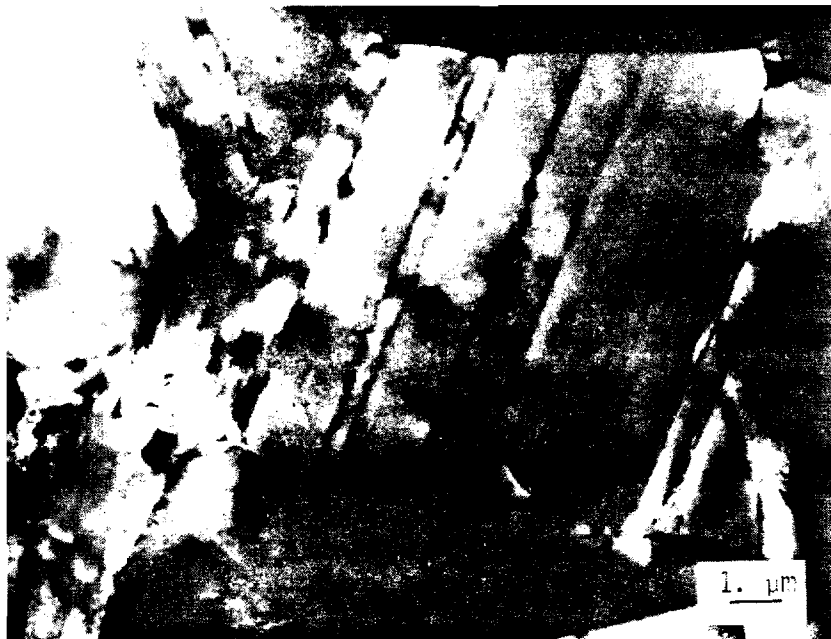
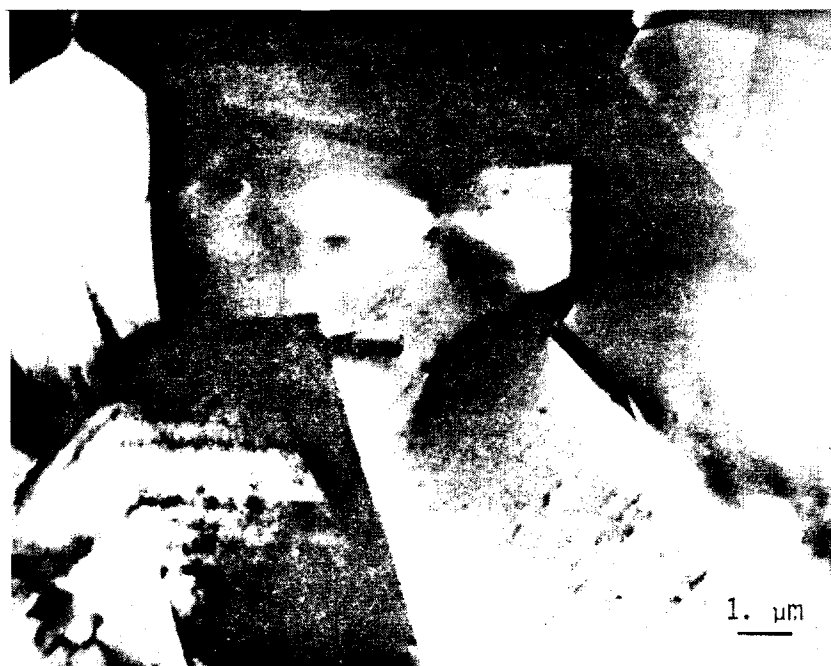
Figure 10. Deformation structure in specimen 9.

Evidence of twinning can also be seen in Figures 10 and 11. These specimens were deformed at 427°C. Figure 11 also contains annealing twins shown at position A on the Figure.

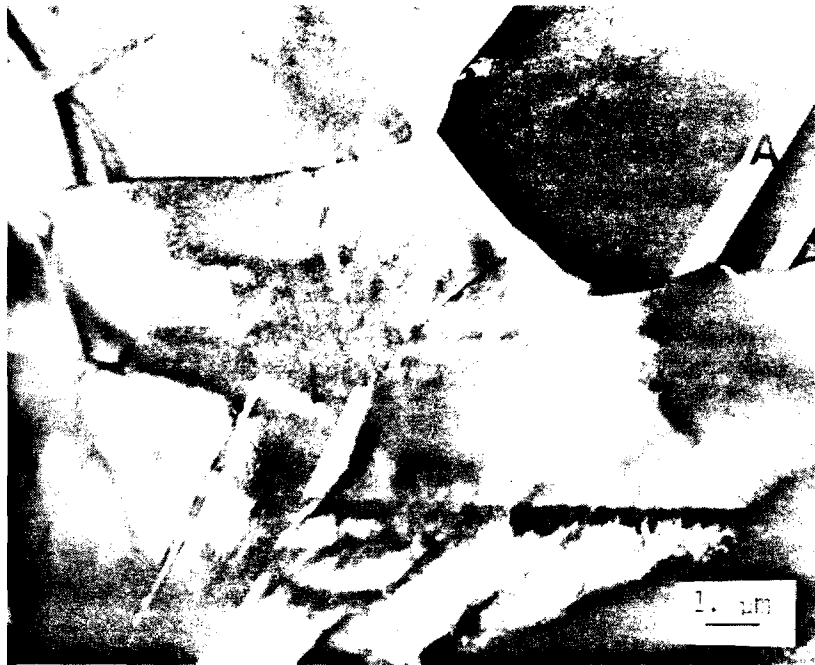
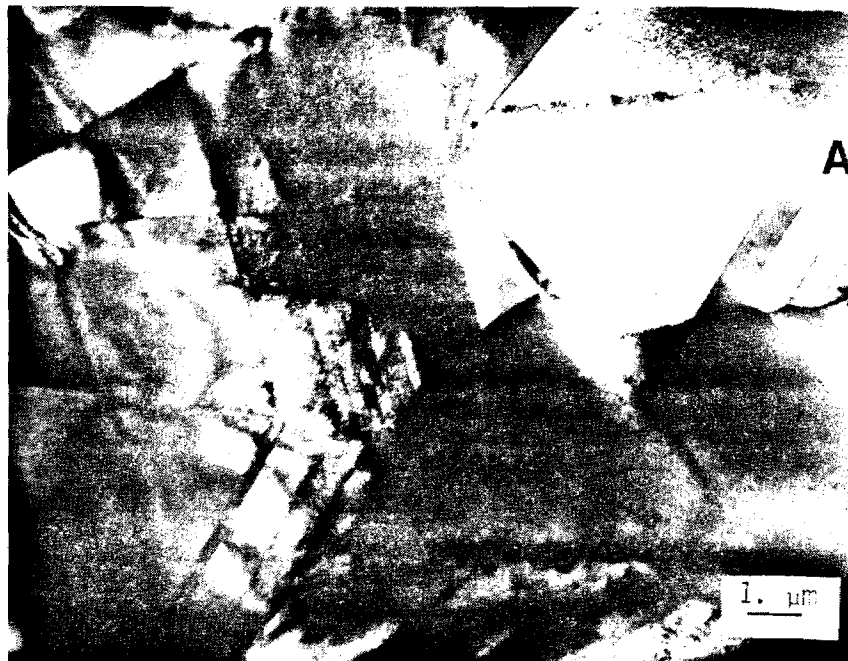
Figure 11. Deformation structure in specimen 9.

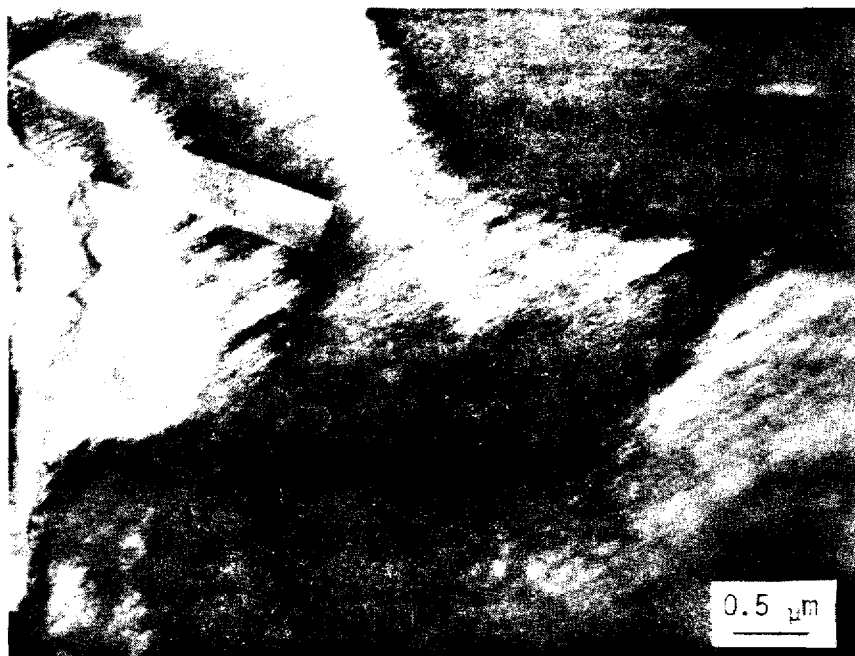
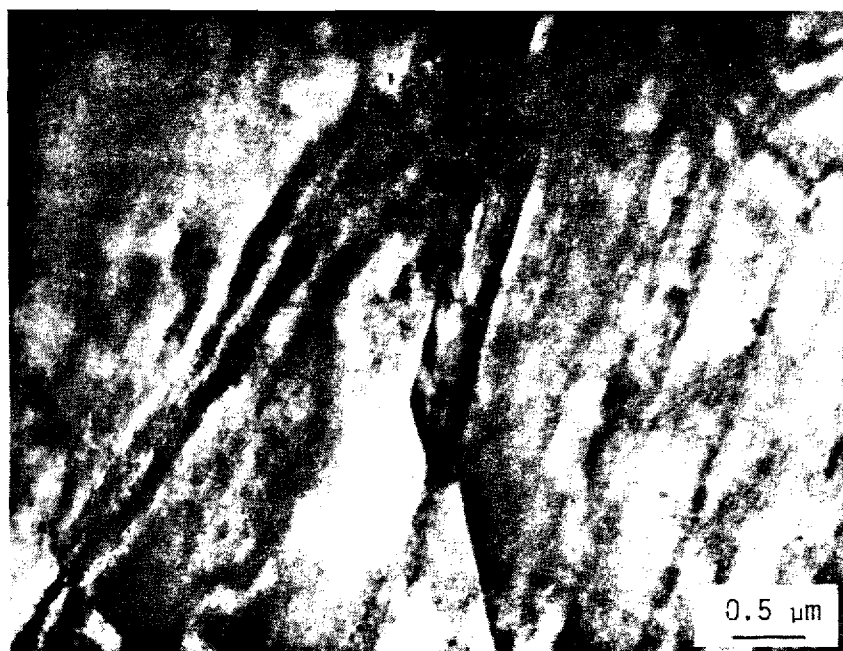
Figure 12. Deformation in specimen 4. Note the difference in the appearance of the deformation as compared to Figures 3 and 4, for example.

At the two higher temperatures (538°C and 649°C), the primary mode of deformation was thought to be by slip, (Figures 12 - 14) since streaking and extra reflections were not observed in the SAD patterns. Furthermore, when slip bands were observed, often incoherent particles were associated with these bands, suggesting that dislocations were generated at the interface between these particles and the matrix.

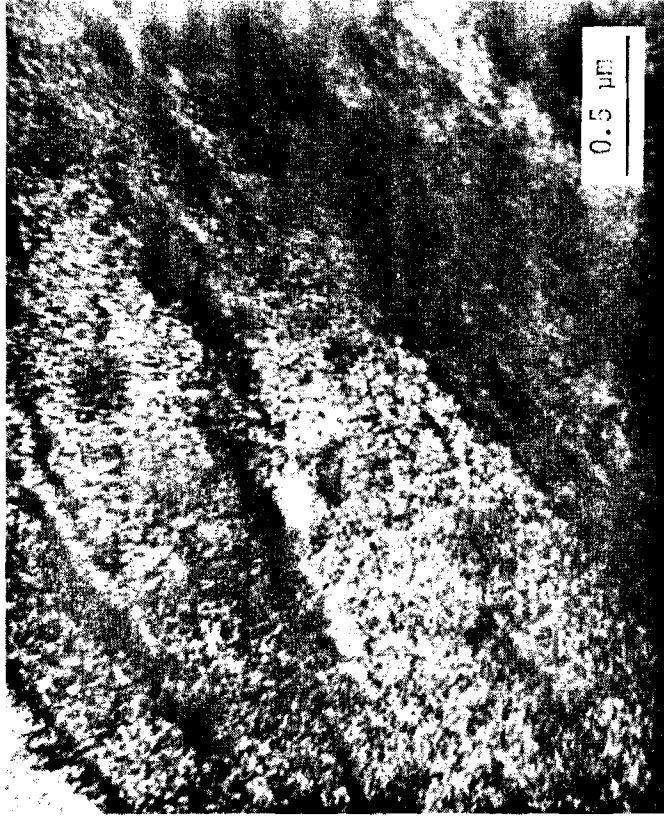
Figure 15. Deformation structure in specimen 35.

Occasionally, however, a favorably oriented grain may twin at the higher temperature. If after the twinning event occurs, successive deformation leads to slip, which is the predominate mode of deformation, the twin will become damaged, Figure 15. The observation of damaged twins has been made in other systems which undergo deformation by twinning and slip.<sup>(4)</sup> The damage of the twin does not occur uniformly since the growth of a deformation twin generates lattice defects which are not uniformly distributed in the vicinity of the twin interface.
